**2016 Data Report  
for  
Gull Lake, Kalamazoo County**

Site ID: 390210

# Gull Lake, Kalamazoo County 2016 CLMP Results

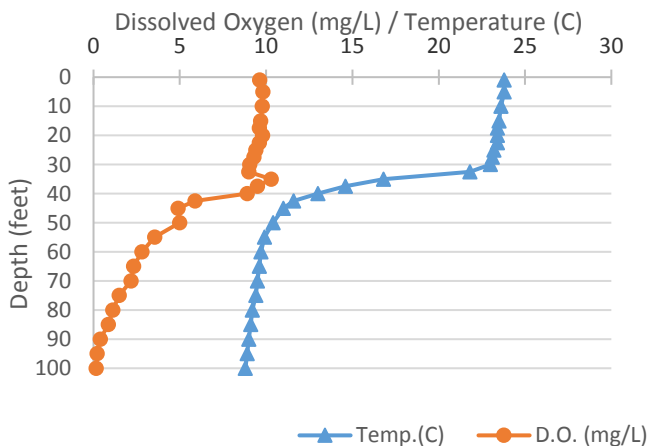
## Dissolved Oxygen and Temperature Profile 9/22/2016

If you enrolled in Dissolved Oxygen/Temperature, the summary page will have a graph of one of the profiles taken during the late summer (typically August or September). If your lake stratifies, we will use a graph showing the earliest time of stratification, because identifying the timing of this condition and the depth at which it occurs is typically the most important use of dissolved oxygen measurements.

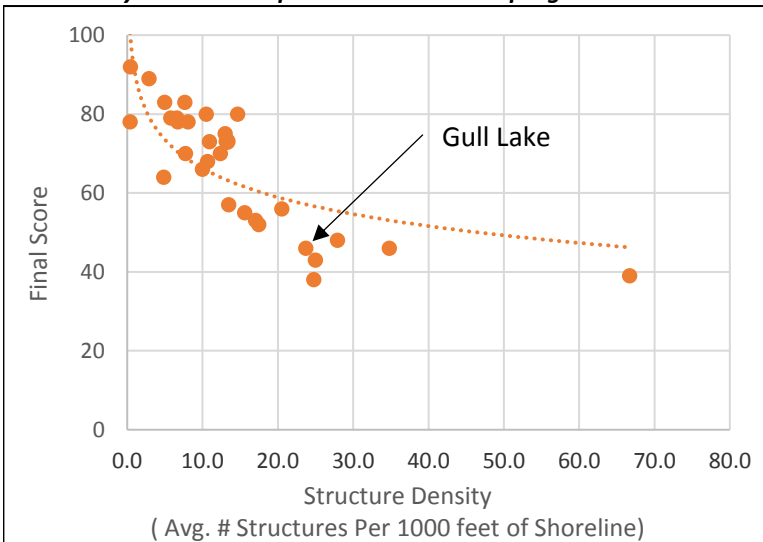
### How does your lake compare to others in the program?

There is a very tight relationship between Final Score and Structure Density. It will be interesting to see if and how this changes as more lakes go through this scoring process.

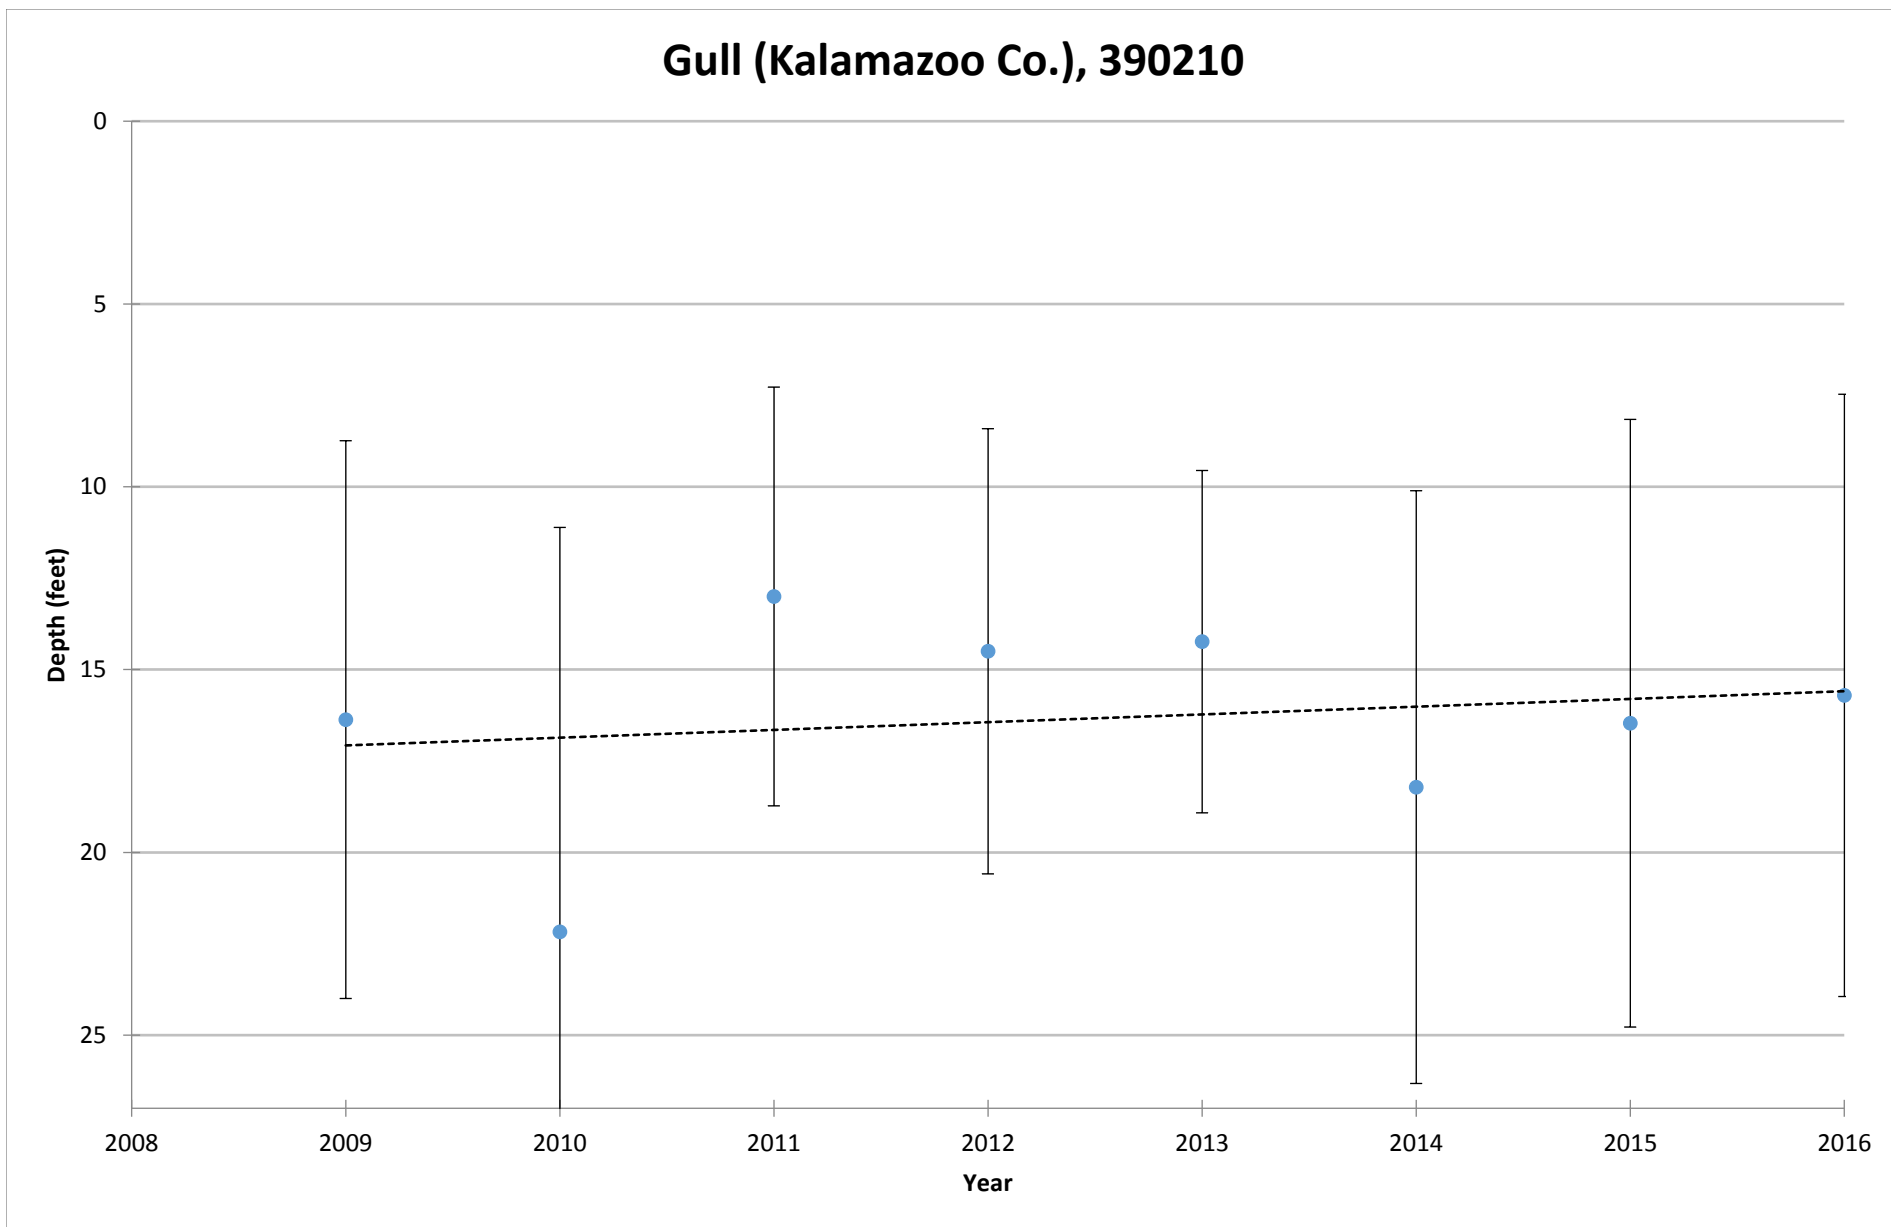
COOPERATIVE LAKES MONITORING PROGRAM  
SUMMER MEAN TRANSPARENCY

Vertical bars indicate standard deviation

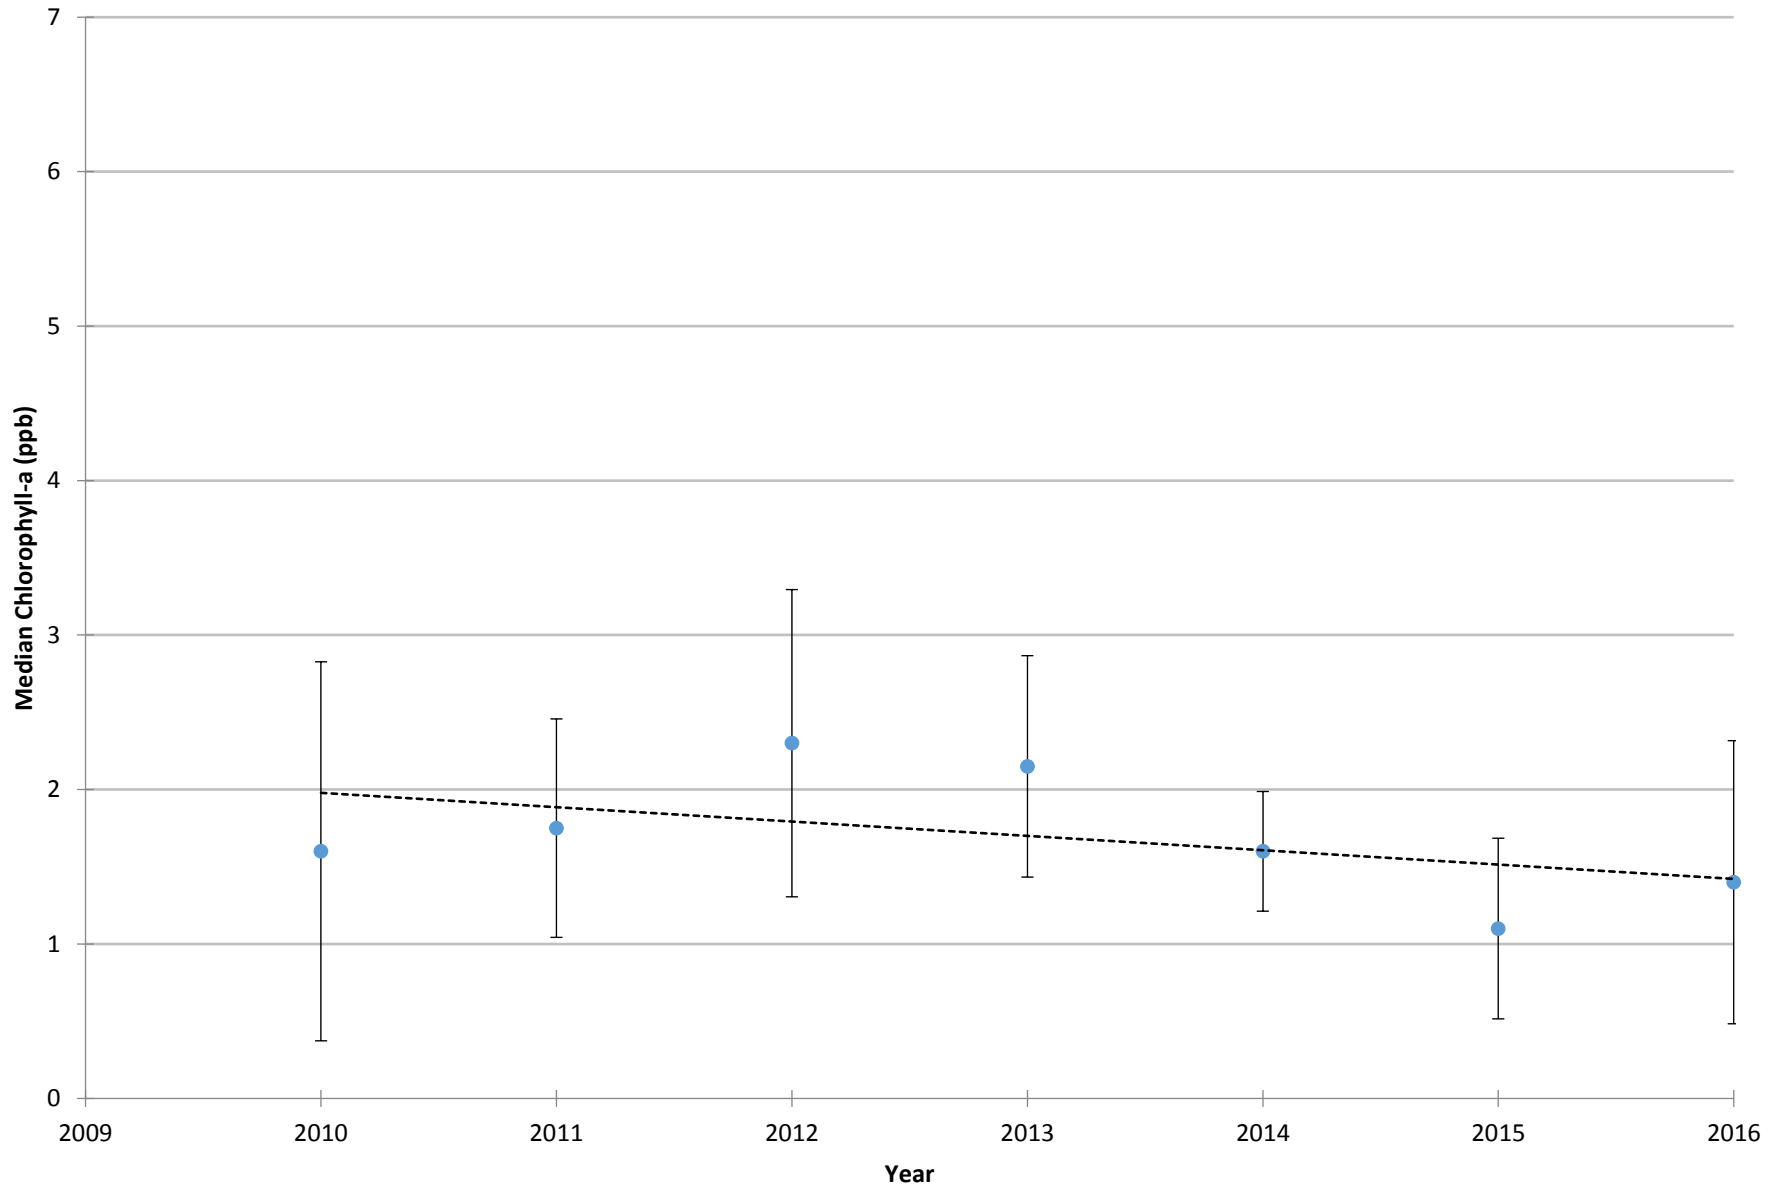
COOPERATIVE LAKES MONITORING PROGRAM  
SUMMER MEDIAN CHLOROPHYLL-A

Vertical bars indicate standard deviation

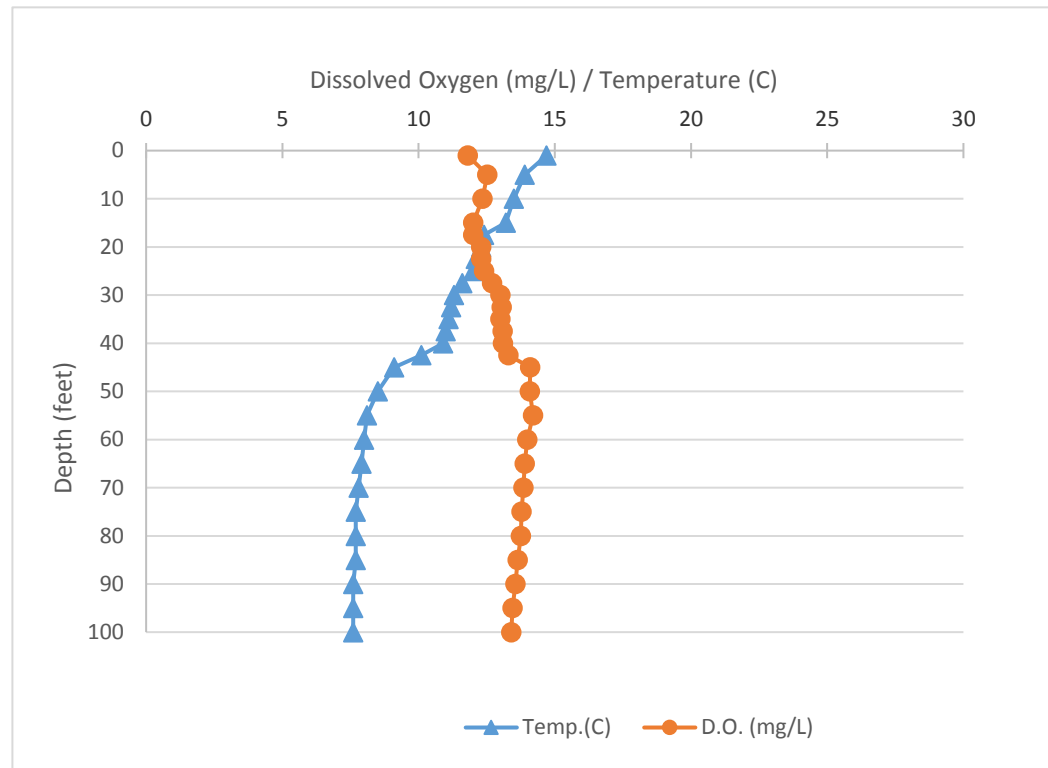
5/19/2016

### Dissolved Oxygen and Temperature Profile

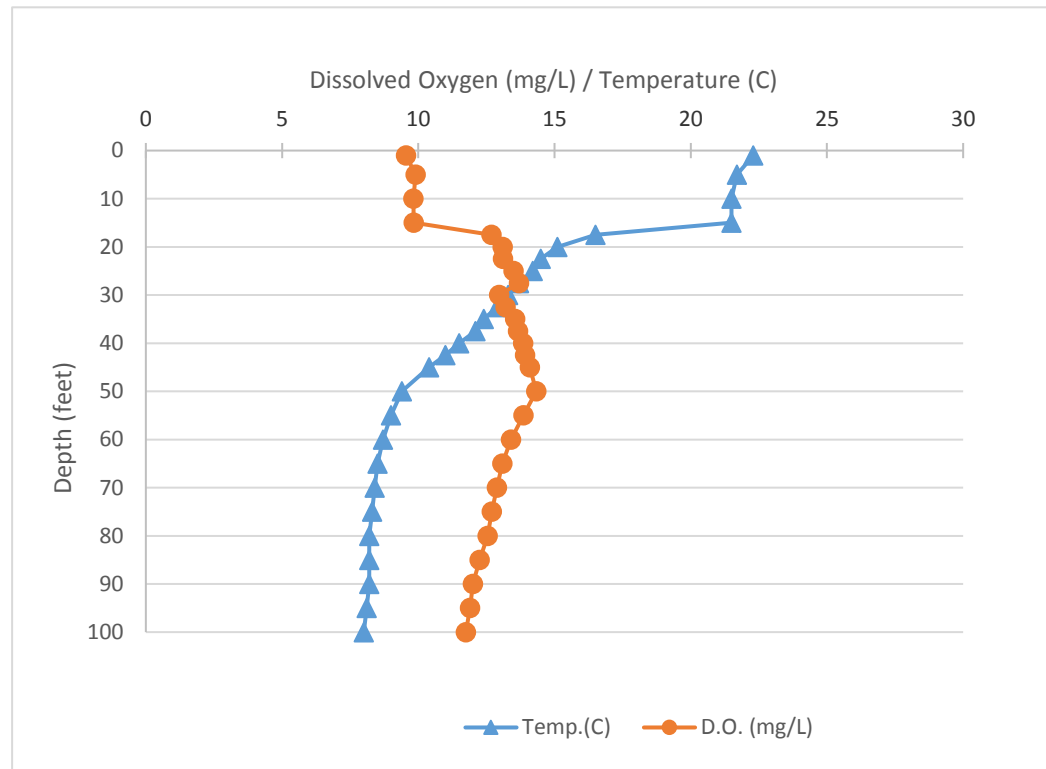
6/3/2016

### Dissolved Oxygen and Temperature Profile

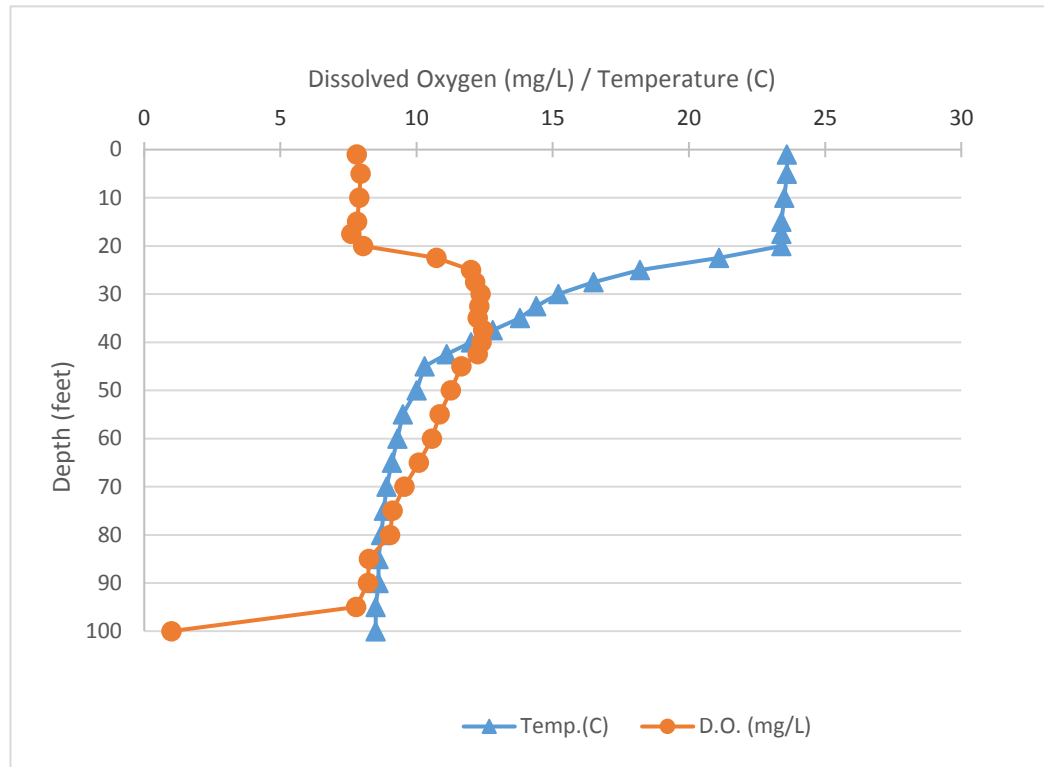
6/28/2016

### Dissolved Oxygen and Temperature Profile

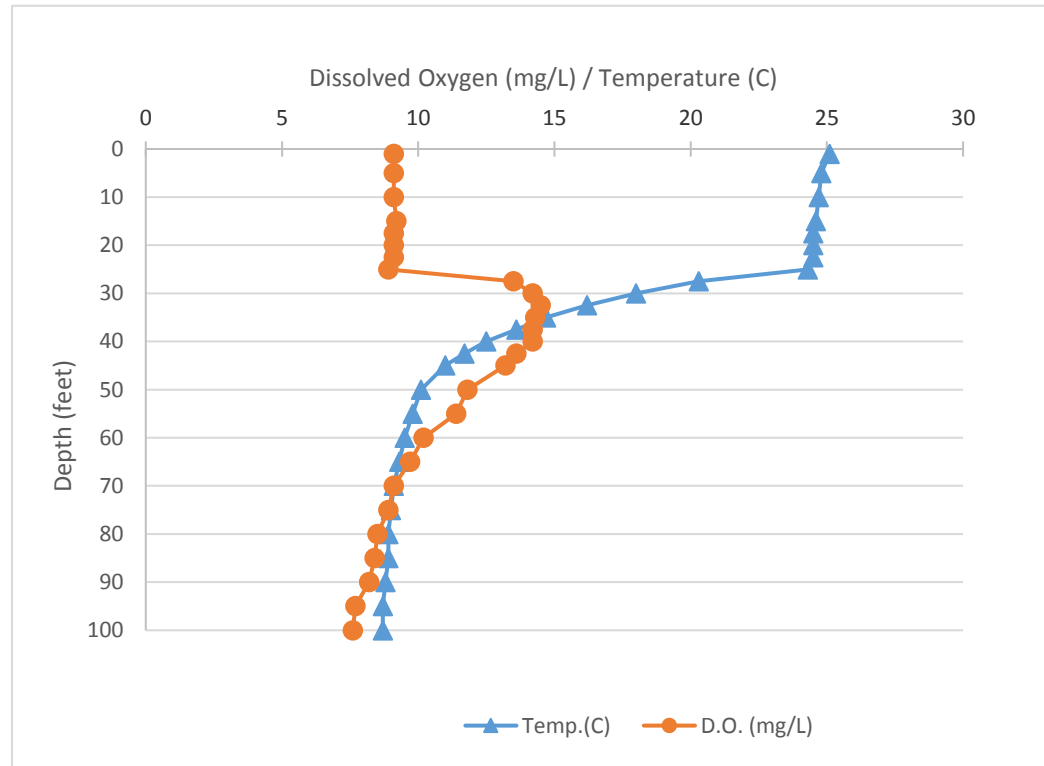
7/16/2016

### Dissolved Oxygen and Temperature Profile

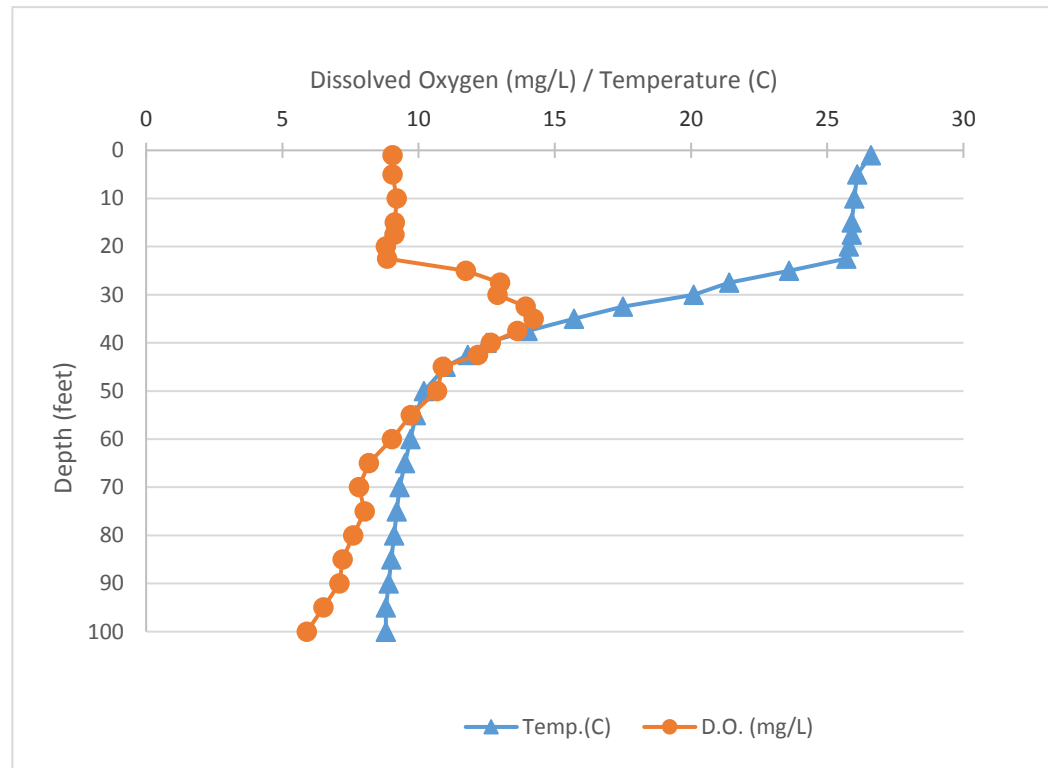
7/31/2016

### Dissolved Oxygen and Temperature Profile

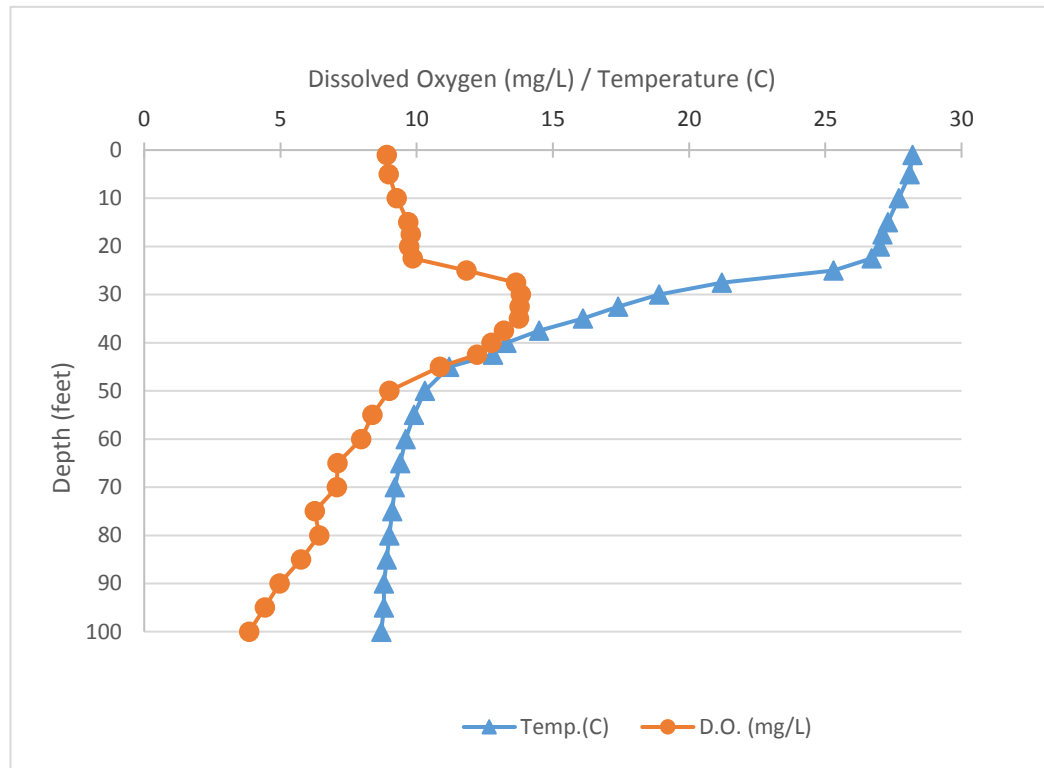
8/12/2016

### Dissolved Oxygen and Temperature Profile

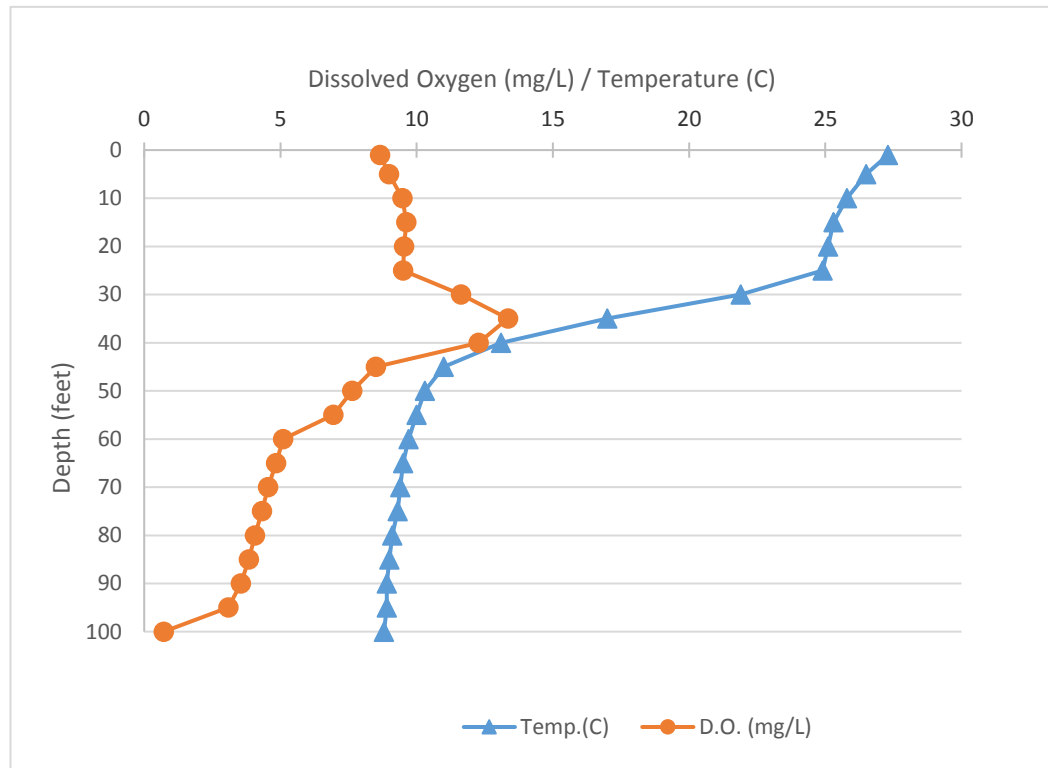
8/29/2016

### Dissolved Oxygen and Temperature Profile

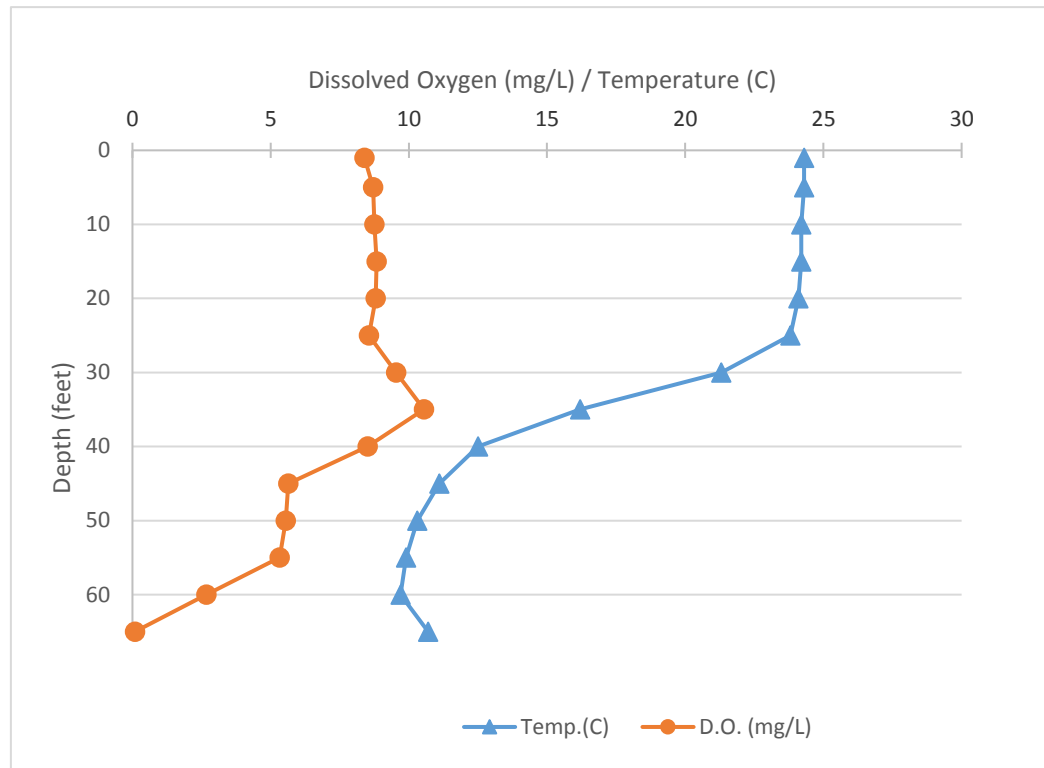
9/12/2016

### Dissolved Oxygen and Temperature Profile

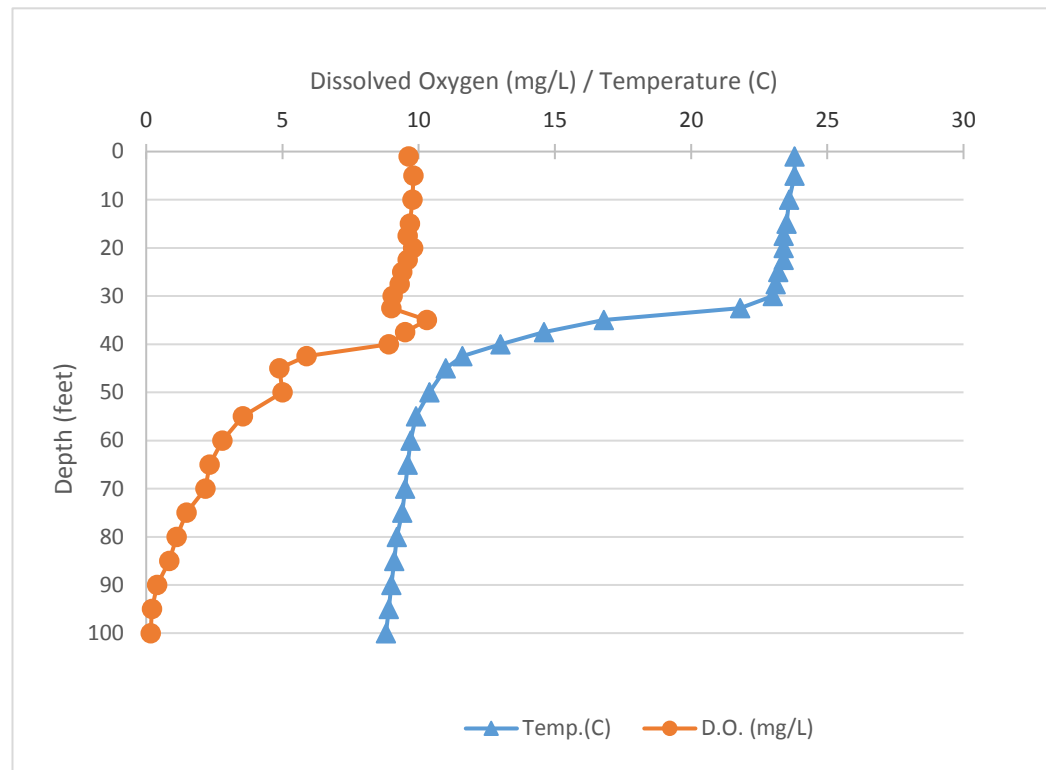
9/22/2016

### Dissolved Oxygen and Temperature Profile
